Solvay Advanced Polymers, L.L.C. Augusta, Georgia

Reduced conveyance system blowouts - significantly decreasing labor, parts and lost-product costs

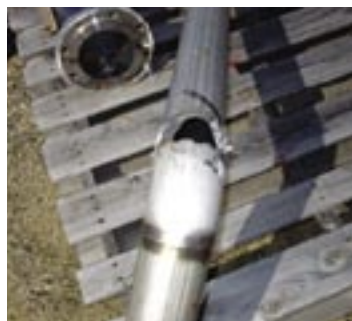
Elbow and pipeline blowouts were common before Solvay installed Conforma Clad® conveyance components.

Undetected blowouts plagued the conveyance system, costing the plant more than \$200,000 annually in lost product, with each hour of undetected blowout costing \$4,000. The plant spent an additional \$60,000 a year on labor to repair the daily equipment blowouts. Eventually, the blowouts began to create significant yield reductions, affect process distributions and cause safety and housekeeping issues.

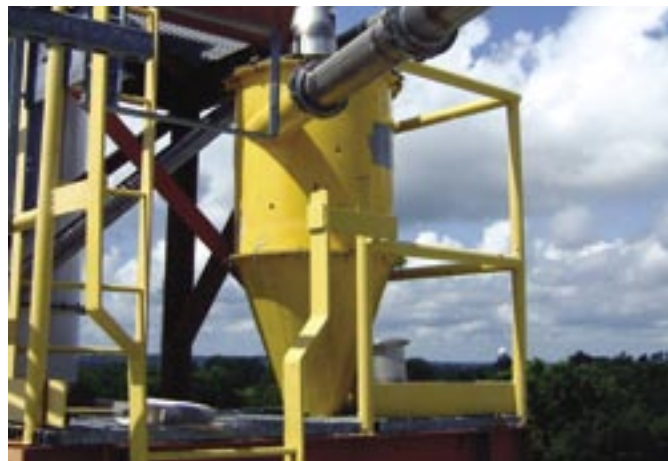
Cyclone clad with Conforma Clad® infiltration brazed tungsten carbide wear protection.

Our proprietary infiltration brazed tungsten carbide cladding is metallurgically bonded to component surfaces. Conforma Clad's cloth delivery system enables densely packed tungsten carbide to be uniformly applied to complex geometries, providing a protective layer that wears at a uniform and predictable rate. The result is a durable cladding that is extremely abrasion and corrosion resistant.

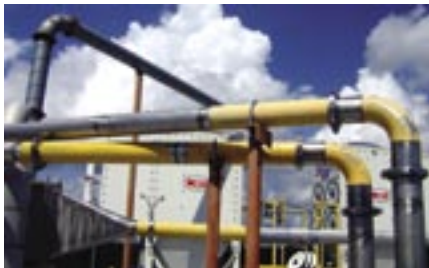
Solvay paints Conforma Clad® components yellow to distinguish them from unprotected piping.

they concentrate on proactive projects instead of reacting to unexpected blowouts. Branham says, "Every time an unprotected pipe blows, we replace it with one from Conforma Clad. We paint all of the Conforma Clad® parts yellow. One day, we'd like to paint the whole line yellow."
